Improving Bicycle Crossings at Unsignalized Intersections through Pavement Markings:
Analysis of the City of Portland Innovative Strategy.

Master of Science
in
Civil and Environmental Engineering

Portland State University
©2021

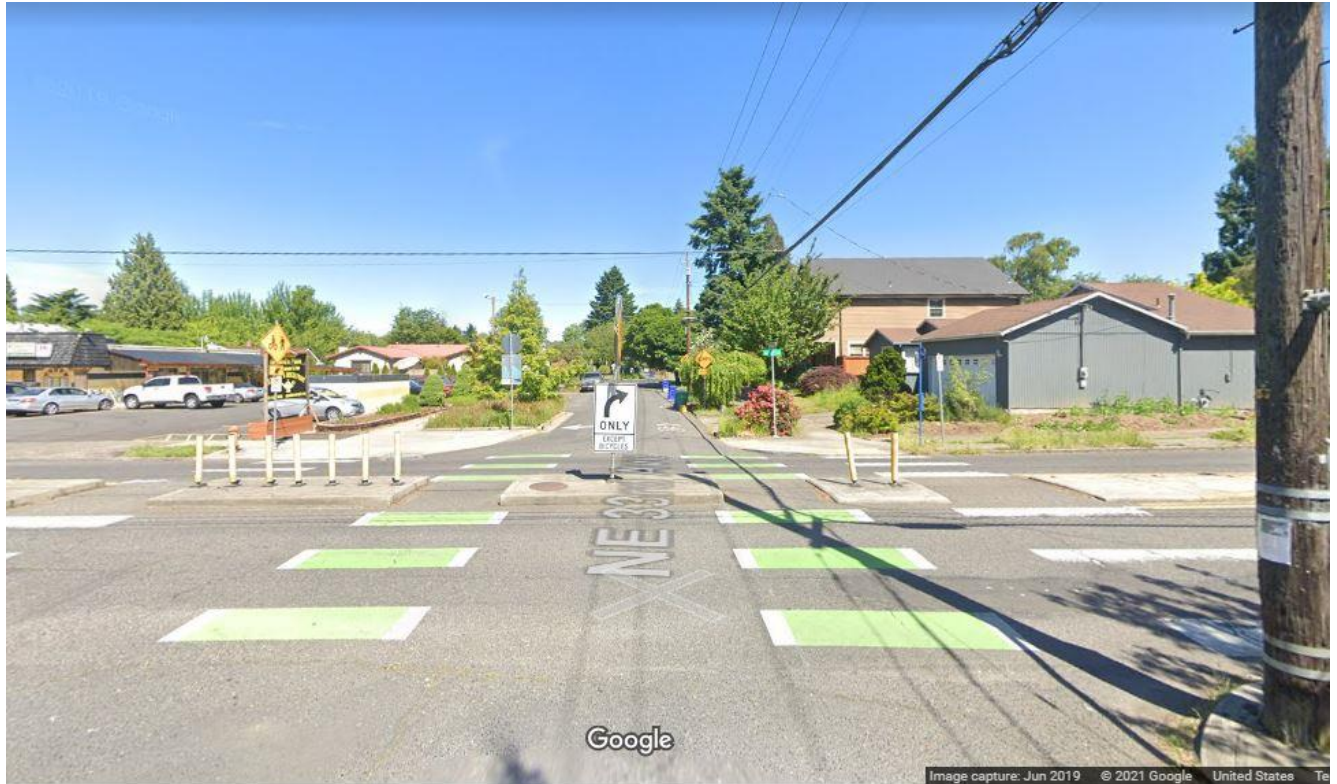
Figure 1: Typical intersection with cross-bike pavement markings.

Cross-bikes are visibly prominent pavement markings that are the equivalent of crosswalks for bicyclists installed at intersections to heighten the visibility of the facility as a bicycle crossing. These markings are green and are marked similar to a continental pedestrian crosswalk. Figure 1 below shows a typical intersection with the cross-bike markings. The city of Portland has adopted this innovative strategy to heighten the visibility of intersections to enhance bicyclist's safety at intersections. The treatment has been installed at selected unsignalized intersections within the Portland metro area over the years. To understand the operational effectiveness of cross-bikes, a

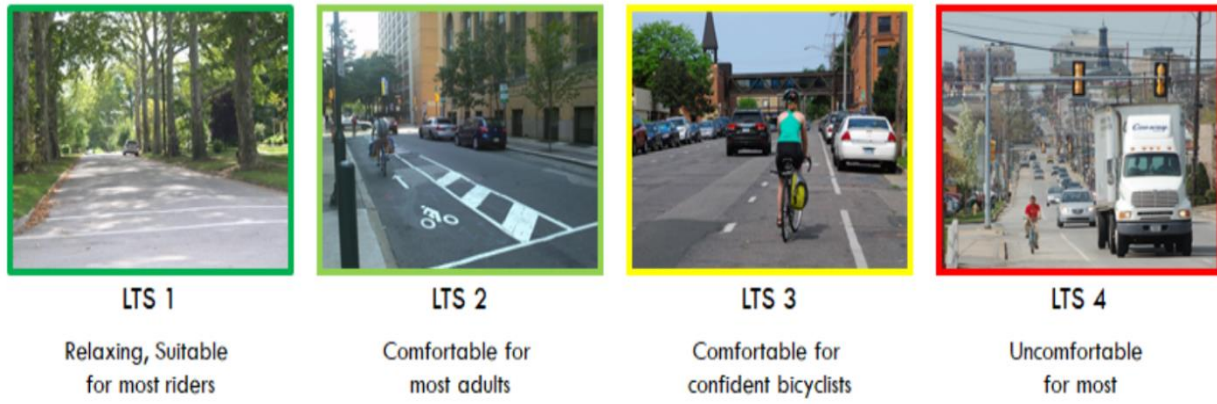
Figure 2:Types of roadways with associated bicycle level of traffic stress. Source : BLTS Types

unsafe by adult users which make it difficult to cross safely. The figure below shows example of each stress level and the facility type.

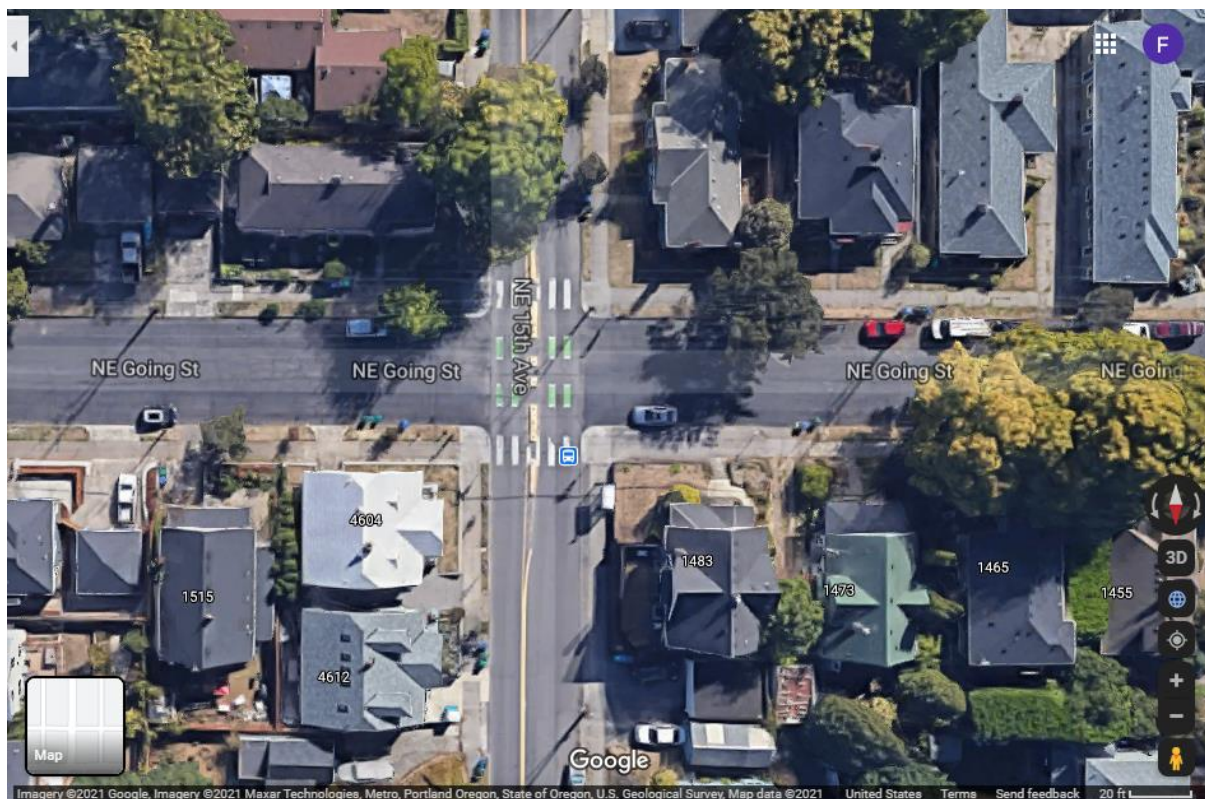
Figure 5: Plan view of NE Going & NE 15th Ave after marking. Source: Google Map

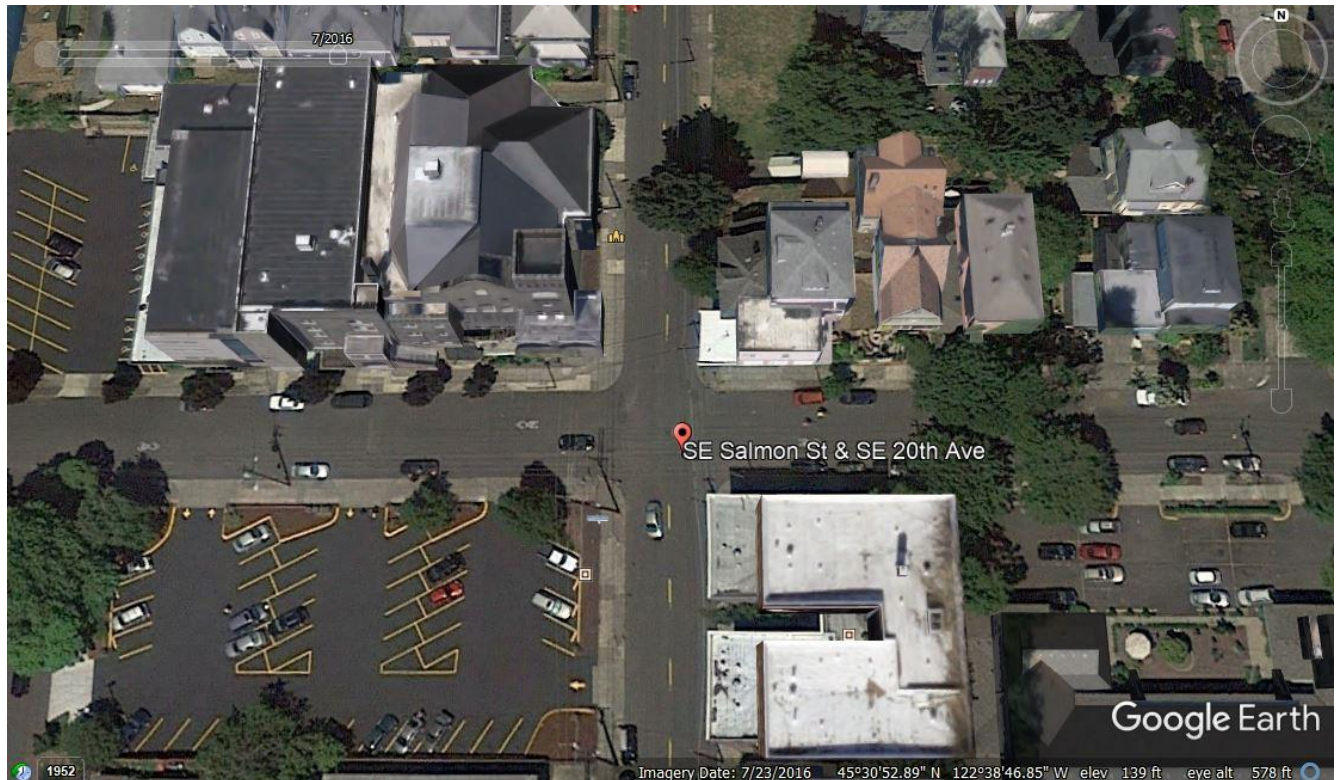
Figure 6: Plan view of SE Salmon & SE 20th Ave. Source: Google Earth (2016).

Also, a four-leg unsignalized intersection with a two-way road for all the approaches. All approaches have posted speeds of 25mph. SE 20th Ave is a north south roadway and serves a mixed traffic with average daily traffic of about 4,000 which are predominantly motor vehicles. SE Salmon is a bicycle boulevard. It serves average traffic of about 785 vehicles including bicycles. The site had no marked crosswalk on any of the approaches prior to the studies.

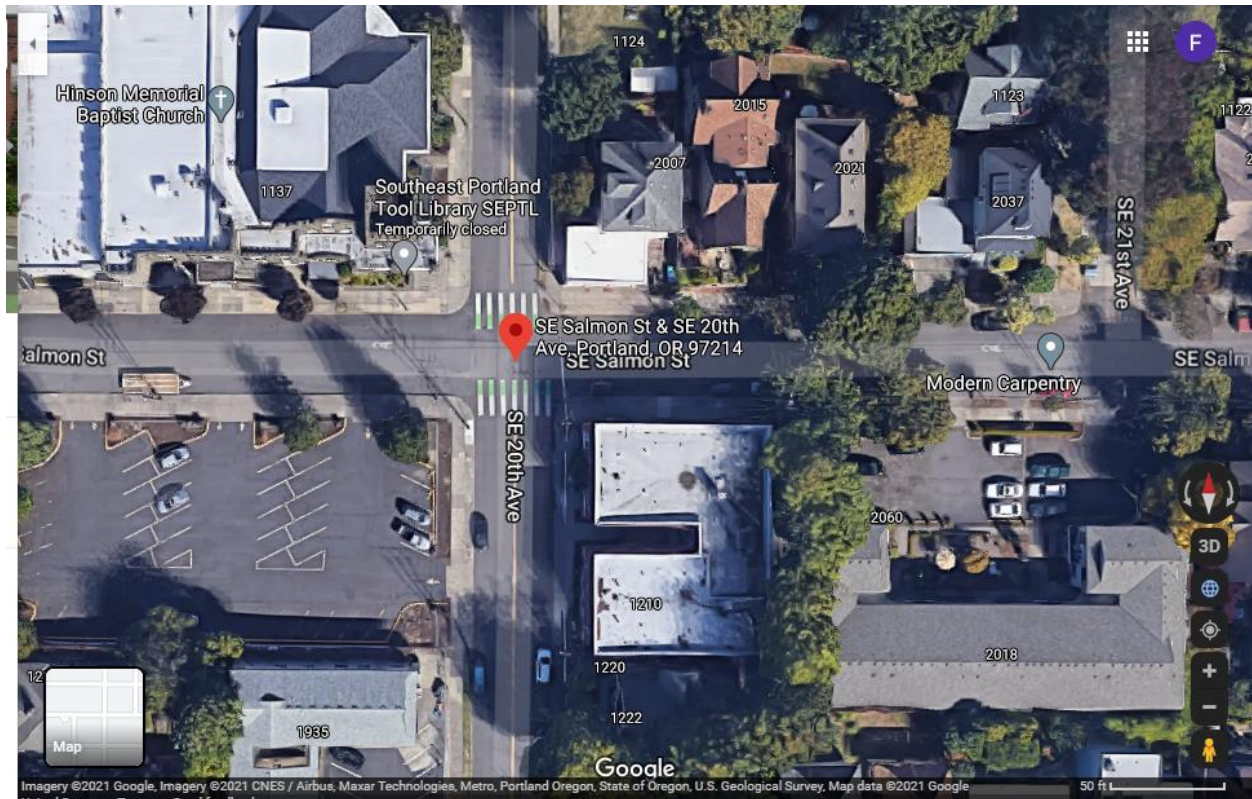
Figure 7: Plan view of SE Salmon & SE 20th Ave after cross-bike marking. Source: Google Map Photo.

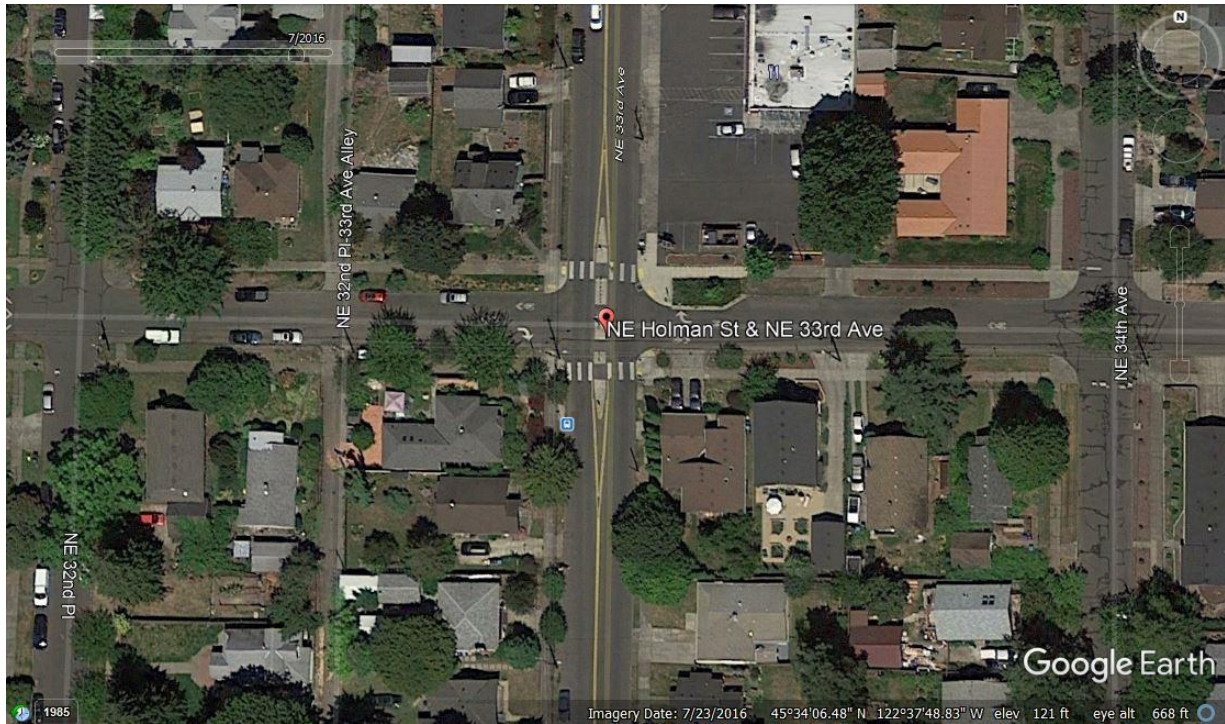
Figure 8: Plan view of Holman & NE 33rd Ave before marking. Source: Google Earth (2016).

NE 33rd is in the north south direction and has a median and a marked crosswalk on its approaches. It is a busy approach that serves average daily traffic of about 5,420 vehicles at a posted speed of 30 mph. NE Holman is a bicycle boulevard that serves mixed traffic which are predominantly bicycles. It serves a relatively low average traffic of about 270 and has a posted speed of 20mph. The presence of median island on NE 33rd make crossing from either approach for motor vehicles on NE Holman impossible except for right turning onto NE 33rd. However, bicycles, can cross from either side of Holman through the gaps created through the median for them.

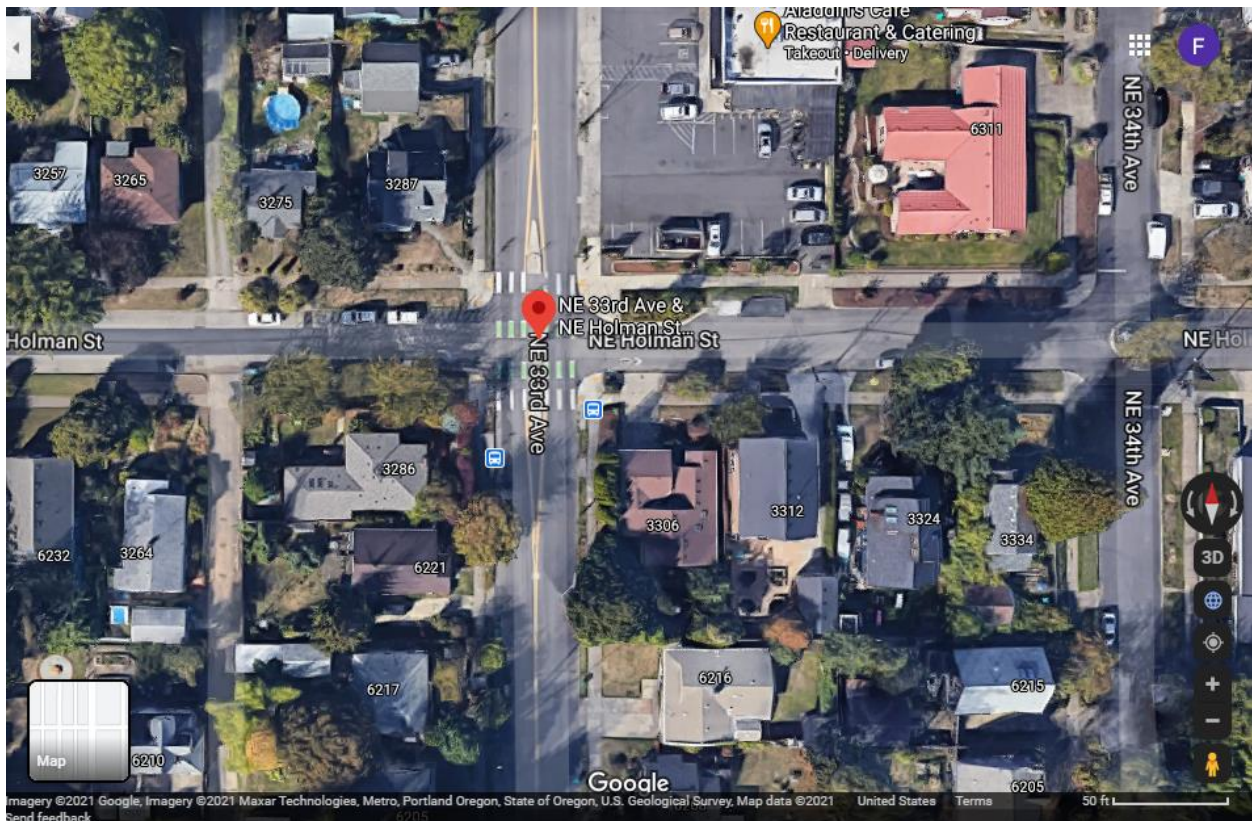
Figure 9: Plan of Holman & NE 33rd Ave after cross-bike. Source: Google Map Photo

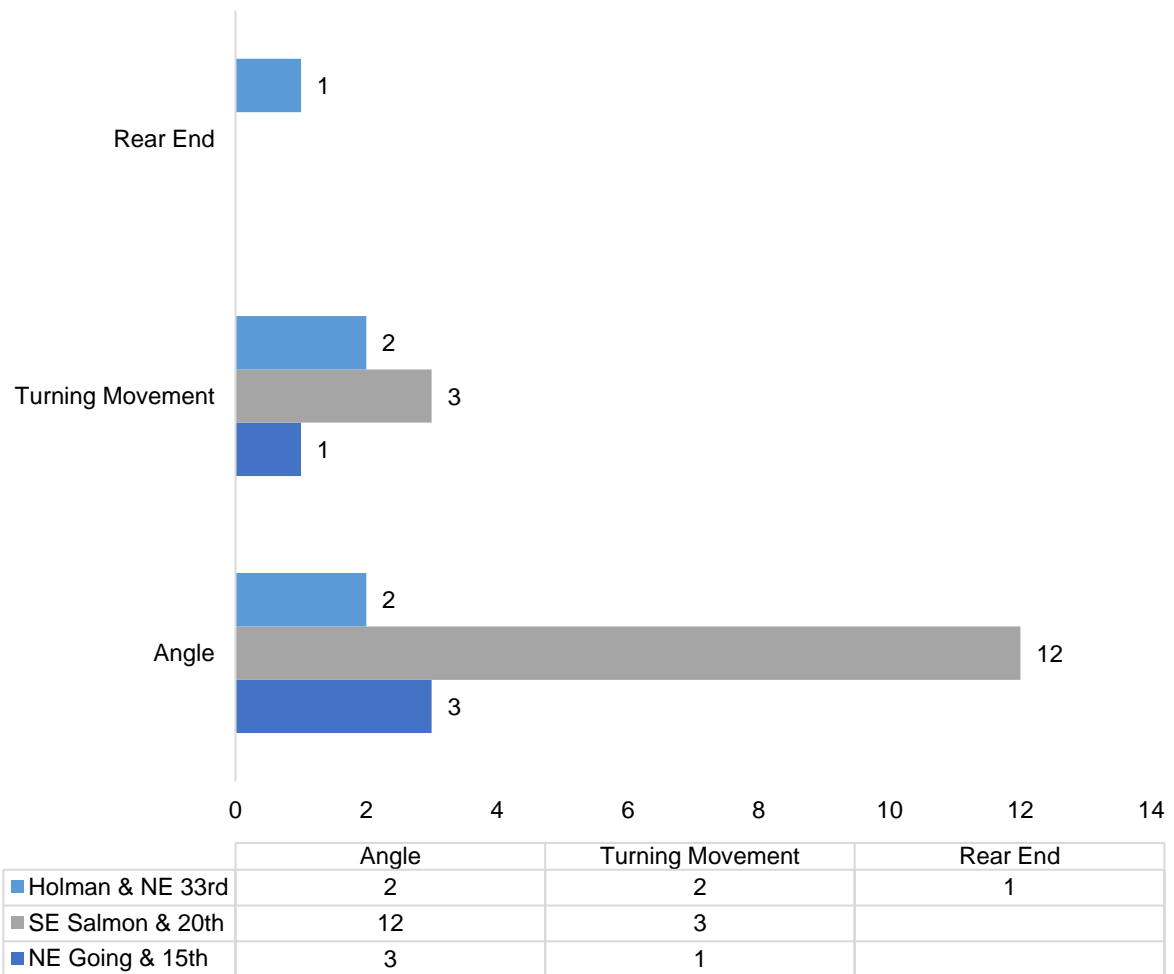
Figure 11: Number of crashes by collision type

A detail look into the types of crashes that was overrepresented at these sites revealed that angle crashes constituted about 70% of the total crashes followed by 25 % of turning movement. Rear-end crash constituted about 5%. All these crashes resulted in only property damages. The table and figure below give detail representation of the crash types.

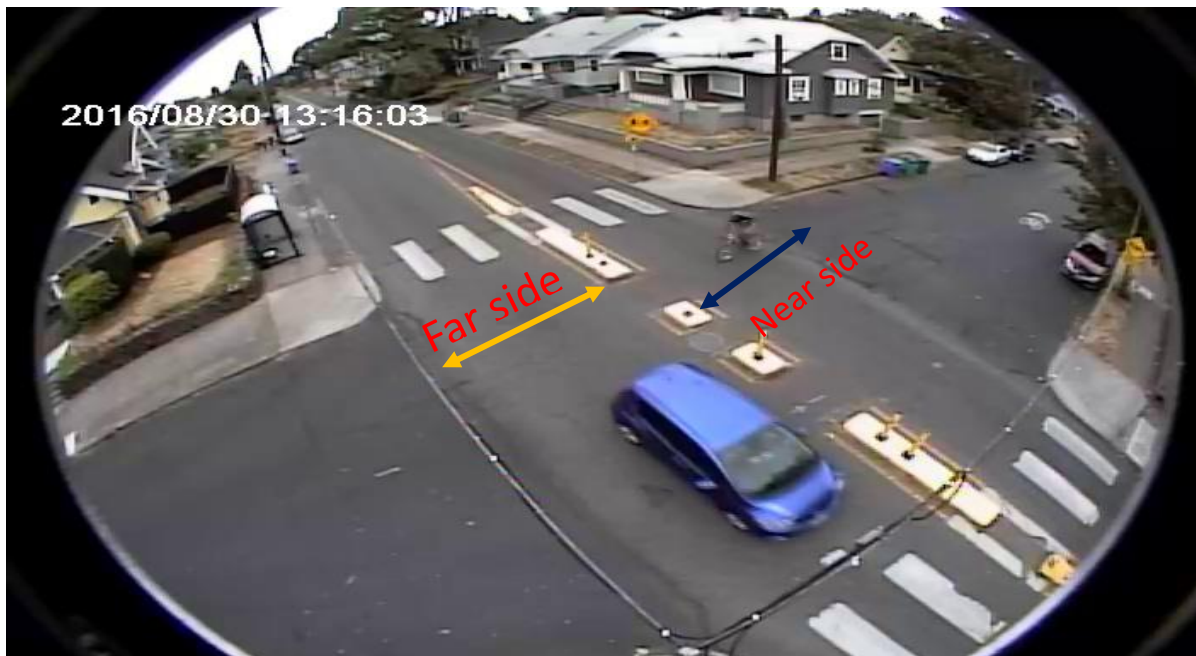
Figure 12: Plan view of NE Going & NE 15th Ave illustrating near and far sides for a bicycle crossing.

Near & Far side: Relative to the location of the waiting bicyclist, the near and far side at the crossing changes. The near side is usually the immediate lane where the cyclists waits for safe gap to cross the street. The figure below gives a pictorial detail of the positions being discussed. The lane adjacent the waiting cyclist is the near side while the lane where the blue car is the far side with respect to this bicycle crossing.

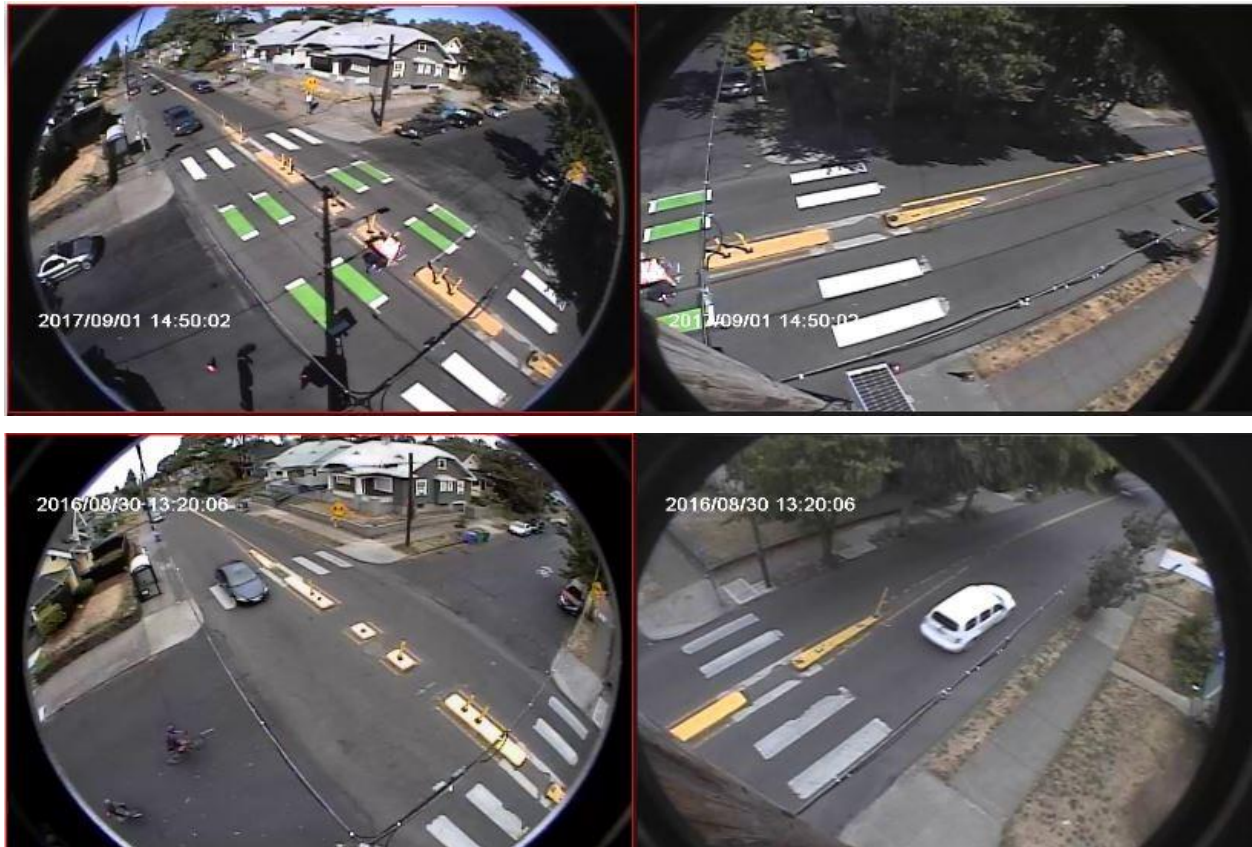
Figure 13: View of data reduction at NE Going & NE 15th Ave for before and after cross-bike installation.

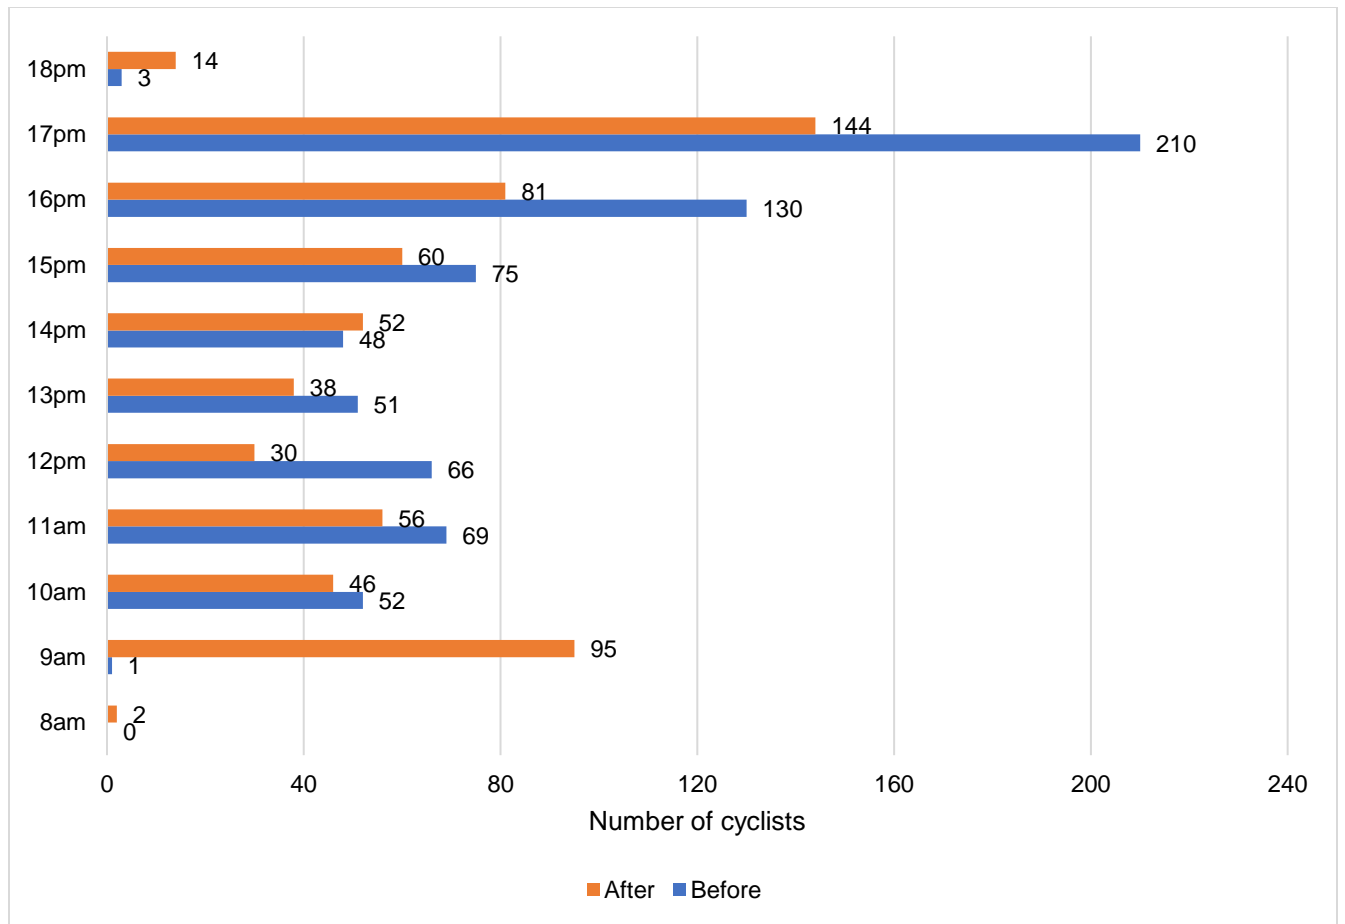
Figure 14: Number of cyclists arriving at NE Going & NE 15th Ave.

NE 15th is a bicycle boulevard that serves a considerable number of bicycle traffic. From the data, the number of cyclists arriving varied continuously throughout the day with high number of arrivals being observed during peak hours. The average number of bicycle arrivals was 64 for the before condition and 56 after the installation of the markings. The figure below shows the number of bicycle arrivals. The highest number of observations for before and after at this intersection is 210 and 144, respectively. This occurred at 5pm during the evening peak hour. The least observation occurred at 8am with no cyclists in the before condition and 2 cyclists after. The table and figure below detail the variations throughout the day.

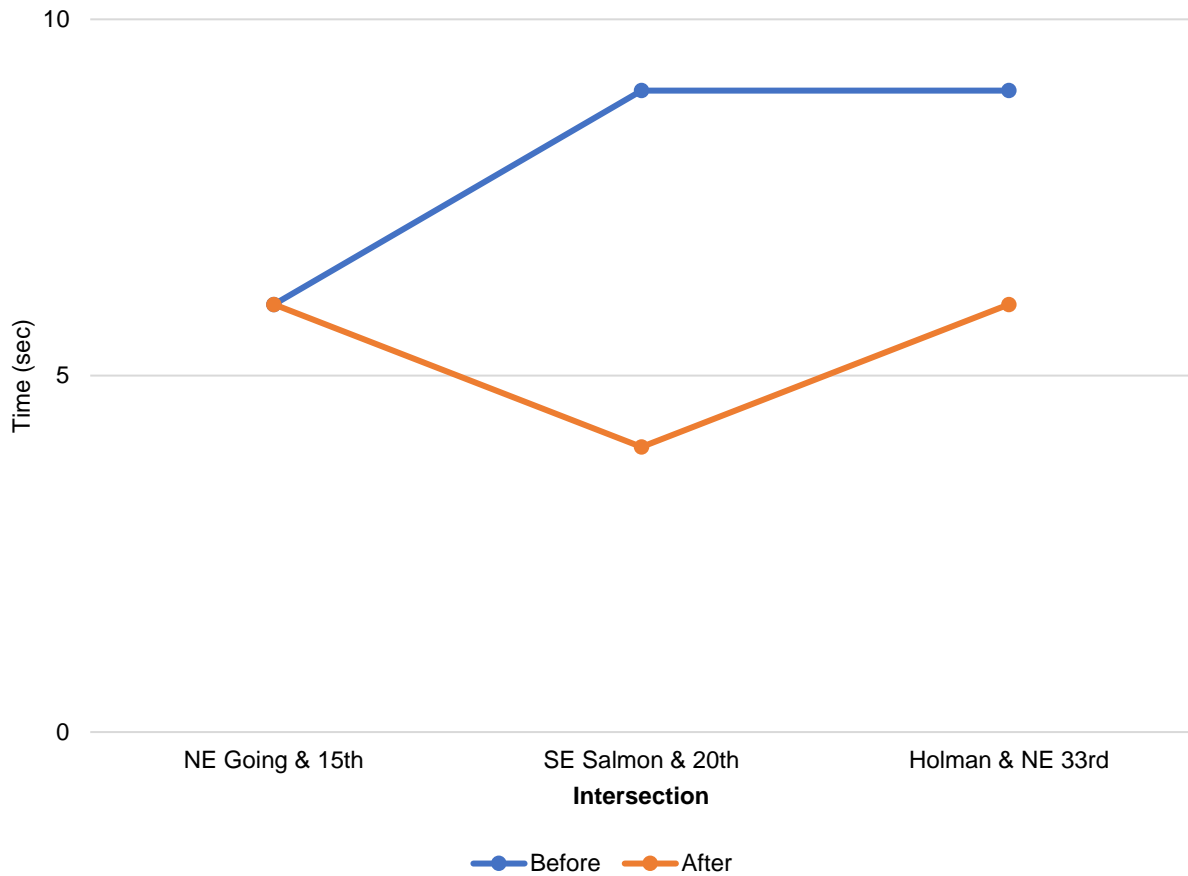
Figure 22: Total average wait time by site.

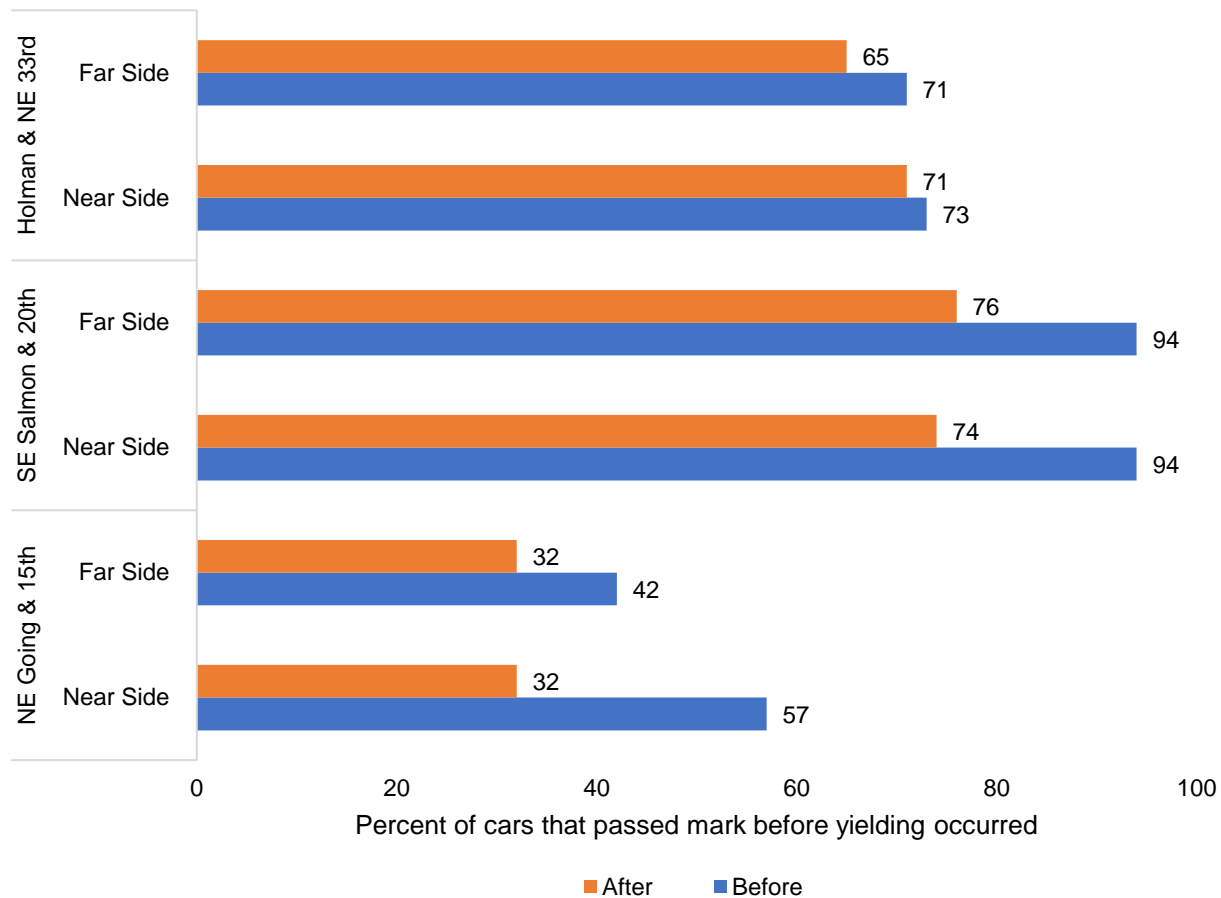
Figure 23: Percent average number of cars that passed mark before yielding by site.

The reduced data took record of the average number of cars that passed the mark before the cyclist gets a car to yield. This data was analyzed for the before and after improvement to evaluate if the treatment had a significant impact on the number of traffic that failed to yield for a waiting cyclist. The earlier discussion established a significant increase in motorists yielding rates after the treatment. However, the subsequent impact on the number of cars that passed the mark before first car yielded was not brought to light by the yielding rates. Evaluating the average number of cars that passed the mark before yielding occurred, it was revealed that each site recorded a substantial decrease in the number of cars that failed to yield. Figure 19 shows the percentage reduction in the number of cars that passed mark before yielding occurred. NE Going & NE 15th recorded a decrease in percentage from 57% and 42% in the near and far side for the before condition to 32% after the cross-bike marking was installed. SE Salmon & 20th also had high percentage of 94% for the number of cars that passed before yielding occurred being reduced to 76 %.
